WELLS Counter Point

Volume 4 Issue 1, January 2000

Idle-Speed Controls

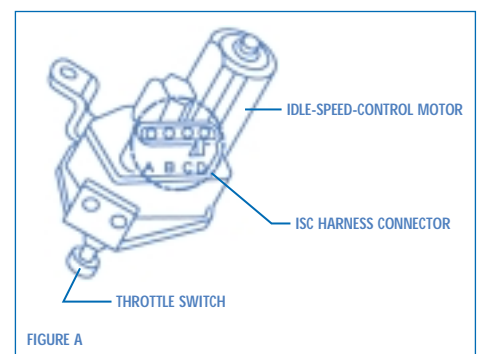
Grounding terminal "D" on the back of the ISC motor and applying battery voltage to terminal "C" should cause the plunger to fully retract (See Figure A). Reversing the connections (grounding "C" and supplying voltage to "D") should run the plunger all the way out. If nothing happens when you jump the ISC motor, the motor is defective and needs to be replaced. But if it works, the problem is in the wiring or ECM.

Do not jump the ISC motor after the plunger reaches the fully-extended or retracted position

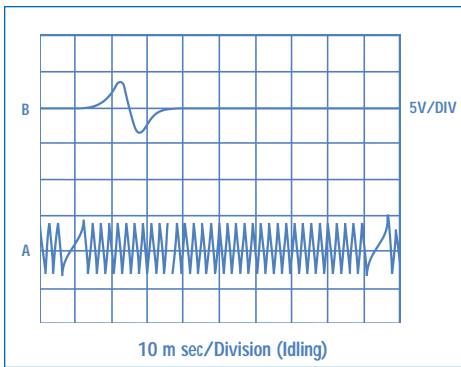
An intermittent crankshaft position signal may be causing the problem. In addition to the sensor itself, loose or corroded connectors or wiring could be the cause. The scope patterns shown below for the crankshaft position sensor (A) and the camshaft position sensor (B) are typical. Lightly tap on the sensor and wiggle the wiring harness and connectors while looking for an interruption in the signal.

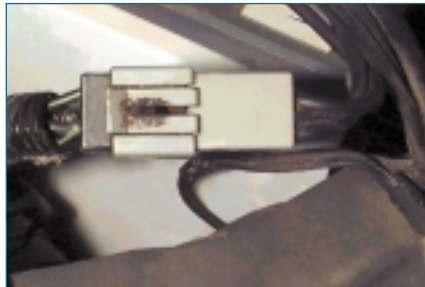
Actually Mike, I have seen this before. In each case, the problem turned out to be a bad ground connector located near the battery and was accompanied by a buzzing IRCM and clicking injectors. Repair of this connector and the associated ground connections will solve the problem.

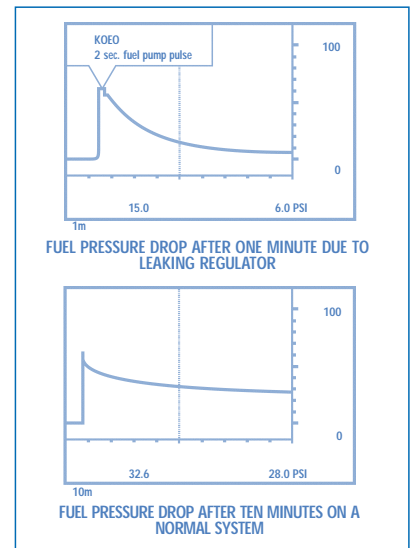
In cases like this, it is common for a leak to occur in the housing that holds the fuel injector and pressure regulator. Depending on where the leak is, it can affect one side of the engine more than the other. Since all of the plumbing is inside the intake plenum, a fuel-pressure leak-down test would be one way to verify a leak. After running the engine (or just the fuel pump) and shutting it off, the fuel pressure should hold for quite a long time. If there is a leak, the pressure will drop off immediately.

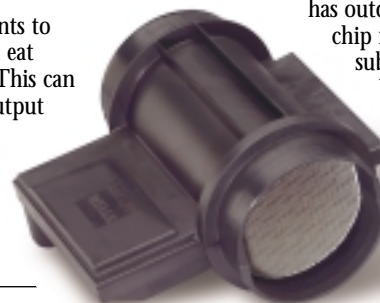
The troublesome OEM MAF sensors on these vehicles have their main circuit board mounted in the airstream. This provides additional

cooling, but also exposes the components to environmental contamination that will eat through the protective epoxy coating. This can result in declining accuracy of MAF output signals and outright sensor failure.

The OEM sensor, by comparison, has outdated wire bonding and chip resistors on separate substrates. That's why WELLS MAF sensors outlast and outperform the OEM sensors.

In the redesigned WELLS MAF sensor, the electronics are relocated out of harm's way. The main circuitry

is safely mounted on a substrate adhered to an aluminum heat-sinking plate, sealed inside an environment-proof housing. The only components exposed to the airstream are the heater element and thermistor. In addition, WELLS also uses a more rugged and compact circuit design with fewer interconnections.
