WELLS Counter Point

Volume 7 Issue 3, July 2003

Forming a Diagnostic Strategy

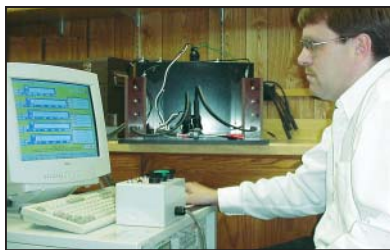
The coil tester supplies the primary windings with a current pulse, while simultaneously monitoring the primary/secondary voltages and current flow. Over two million voltage measurements are recorded for each of the nine test parameters. The computer uses

Using the Wells coil testing system, Engineer Tom Schaefer simulates actual operating conditions.

During the new testing procedures, each coil type is mounted in a specifically designed cradle. It is then run through a battery of tests that simulate the operating conditions the coil would experience if it were running in your customer's vehicle.

these waveforms to determine coil quality. Next, the information collected during the coil test is stored in the computer's memory, right on the production floor. These waveforms and statistics are used by the quality control engineer to evaluate product quality and to make production change recommendations.

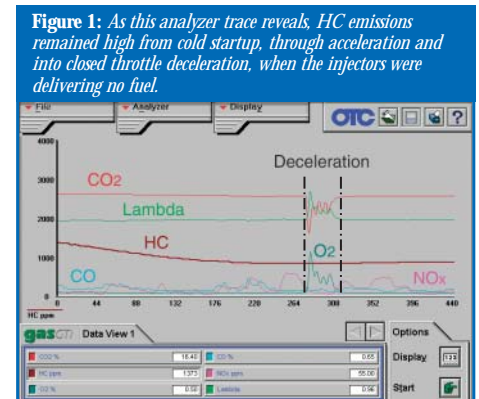
Figure 1: As this analyzer trace reveals, HC emissions remained high from cold startup, through acceleration and into closed throttle deceleration, when the injectors were delivering no fuel.

Other than the Check Engine light and the stored DTCs, the vehicle owner had reported no noticeable driveability problems. Where is the extra, unwanted fuel coming from? To find out more, we measured the post-catalyst exhaust emissions with a five gas exhaust analyzer, immediately after starting the engine cold. The results are shown in graph form in Figure 1.

HC starts out higher than normal and gradually declines. There was an abrupt deceleration between frames 264 and 308. Why is the engine running rich, especially if the PCM is trying to make it run lean? When this occurred, NO_x went down, O₂ went up, Lambda went up (more about Lambda next),

CO₂ dipped and HC stayed about the same (still too high). All of these readings, except the high HC reading, are consistent with a lean mixture. We would expect to see a lean mixture at this time, because the injectors should be closed and all fuel should be cut during closed throttle deceleration. But the high HC reading indicates the presence of unburned fuel. This would seem to indicate that the engine was running rich and lean at the same time, which certainly seems impossible. In the next *Counter Point*, we'll explain how we finished our diagnosis and identified the fault.
