Knock Sensors Do Two Jobs

Knock sensors play a dual role on OBD-II engines. Like other sensors, knock sensors monitor engine operation to optimize performance.

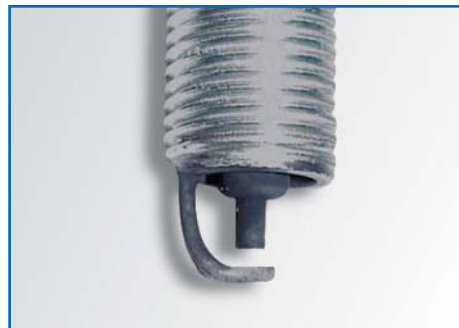
Damaged Spark Plug

Knock occurs when the air-fuel mixture doesn't burn smoothly or is ignited too soon. Knock can be caused by “hot spots” in the cylinder, such as carbon deposits or spark plugs that are too hot for the engine, or high combustion chamber temperatures.

These hot spots ignite the air-fuel mixture before the spark plug fires. The result is two flame fronts, one from the hot spot and one from the spark plug, occurring at the same time. The fronts slam into each other violently as the burning gases rapidly expand.

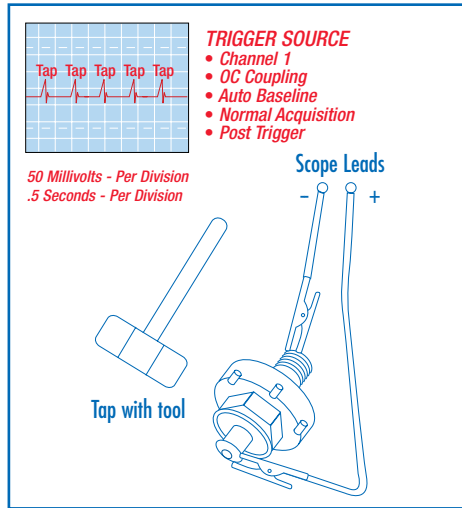
A scope can be used to check the operation of the knock sensor. You can also use your scan tool to check for codes as well as watching the timing changes as you check the operation of the knock sensor. Monitor the knock sensor signal and spark timing while simulating a knocking condition by tapping on the engine block or cylinder head with a soft face mallet. To the sensor, the vibration caused by striking the engine is the same as knock. You should see a signal going from the sensor to the PCM. The PCM, in response to the signal, should retard timing as long as you keep striking the engine block.

When you stop hitting the engine block, the sensor signal should return to the base level and the PCM should advance timing.

If you can simulate a knock signal, you should see timing retarded on the scan tool or timing light. This would indicate that the PCM is functioning properly and the problem is with the sensor or the wiring. If the timing doesn't retard with a simulated signal, the PCM or its wiring may be faulty.

The knock sensor can also be checked using a tester that connects across the sensor terminals. With the engine warmed up and running, rap on the block near the sensor. The tester should flash as you hit the block, indicating that the sensor is sending a signal to the PCM.
