WELLS Counter Point

Volume 6 Issue 4, October 2002

Fuel System Fuel Trim

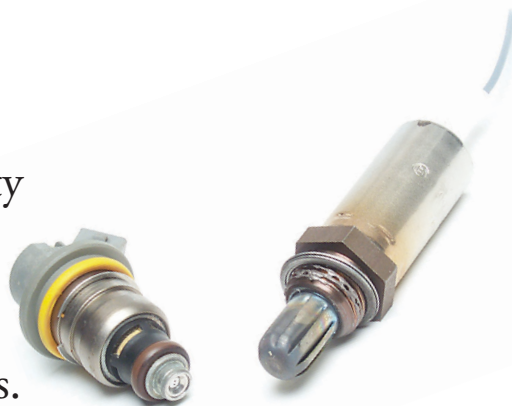
Fuel trim refers to the PCM's ability to add or subtract fuel in response to changing engine operating conditions.

Perhaps you are familiar with what a conventional oxygen sensor waveform looks like. The oscilloscope trace repeatedly travels upward to a peak then downward to a valley, as the oxygen sensor reports the amount of oxygen present in the engine's exhaust. The peaks indicate a rich air-fuel ratio (high oxygen sensor voltage and low oxygen content), while the valleys indicate a lean air-fuel ratio (low oxygen sensor voltage and high oxygen content). When the oxygen sensor reports a rich mixture, the fuel system powertrain control module (PCM) responds by commanding a lean mixture. And when the oxygen sensor reports a lean mixture, the PCM responds by commanding a rich mixture. This is classic "closed loop" fuel control, with the PCM always a step behind in its response to the rich or lean voltage signal from the oxygen sensor.
